The Road Inventory of Hagerman National Fish Hatchery Hagerman, ID

Prepared By:
Federal Highway Administration
Central Federal Lands Highway Division
April 2013

Hagerman NFH - 14230 Summaries

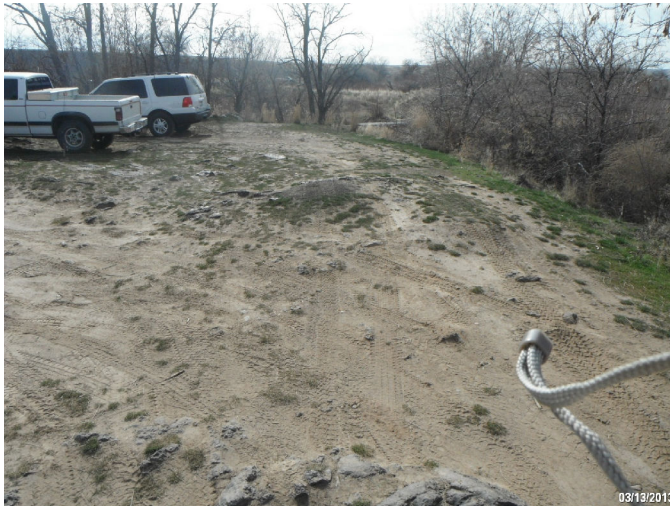
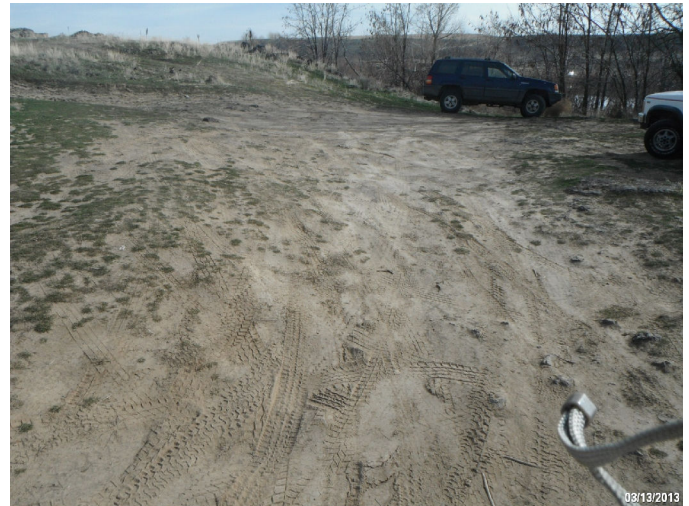
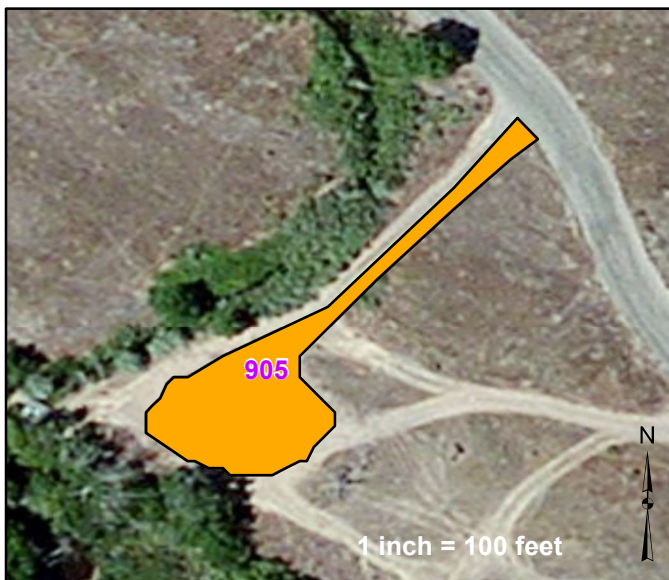
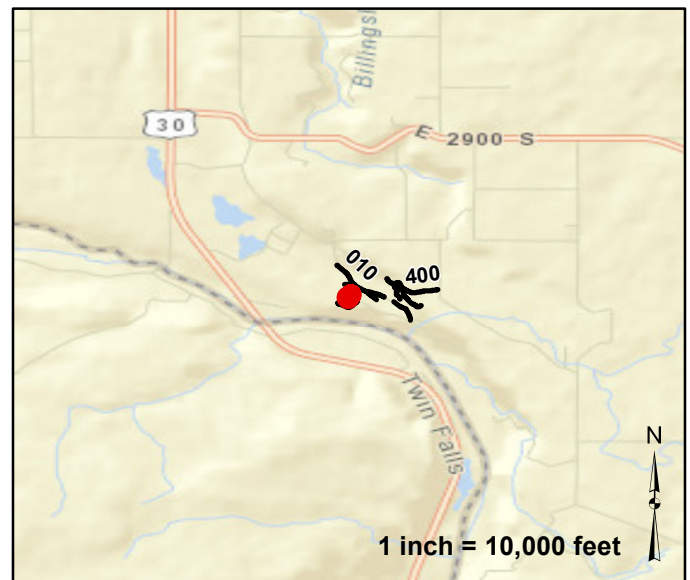
Route Number: 905
Oster Lake North Parking
From National Fish Hatchery Road

Asset Number	Area (Sq Ft)	Spaces	Condition	Surface Type	Cost to Improve	Inspection Date	Current Replacement Value
10063692	4678	6	Poor	Native	\$3,400	03-13-2013	\$9,100

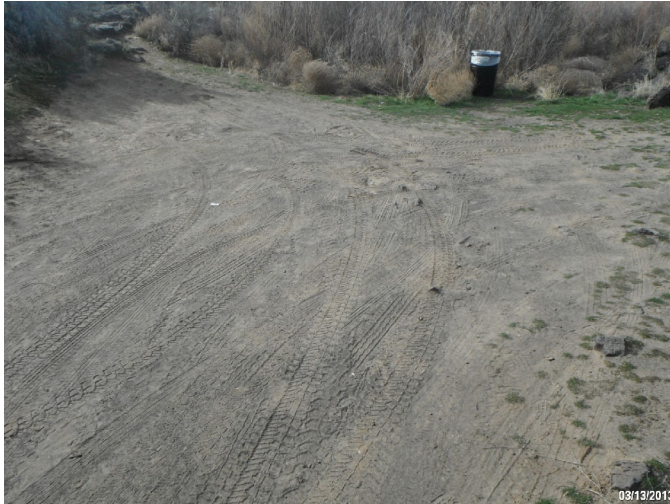
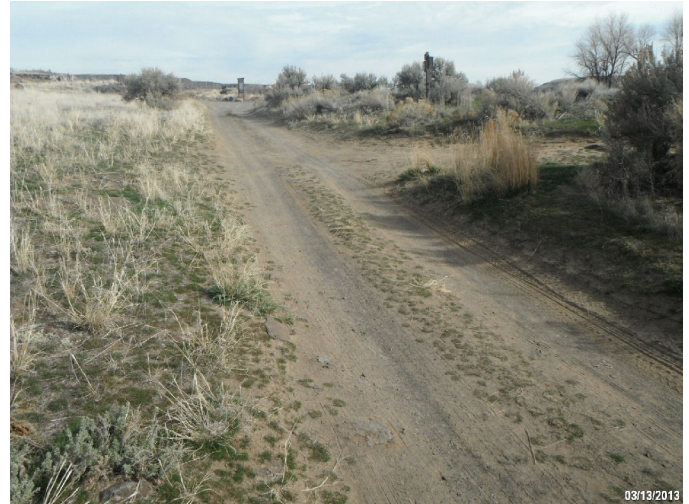
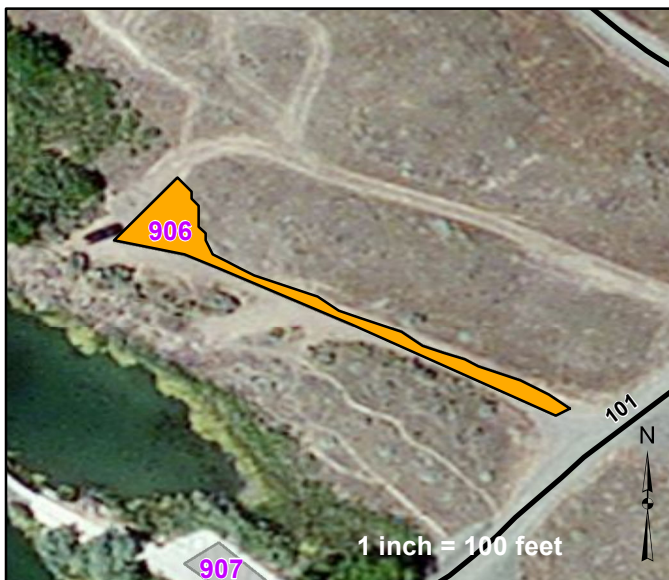
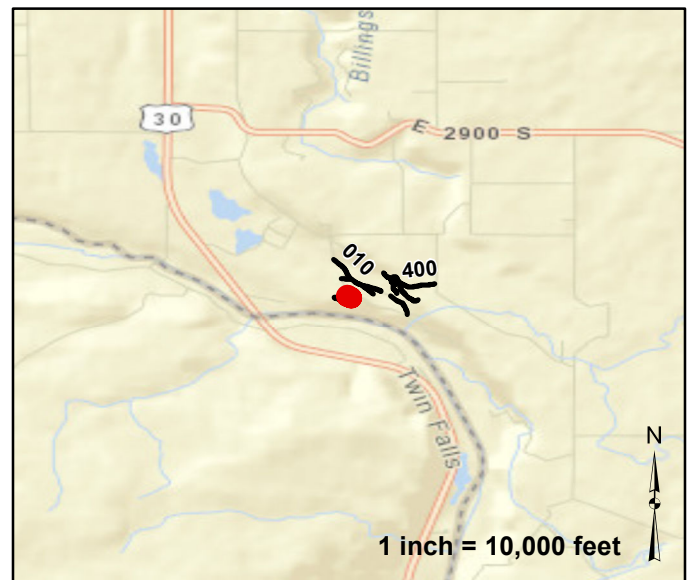
Route Number: 906
Oster Lake Spur Parking
 From Oster Lake Road (Route 101)

Asset Number	Area (Sq Ft)	Spaces	Condition	Surface Type	Cost to Improve	Inspection Date	Current Replacement Value
10063692	1714	3	Poor	Native	\$1,300	03-13-2013	\$3,300

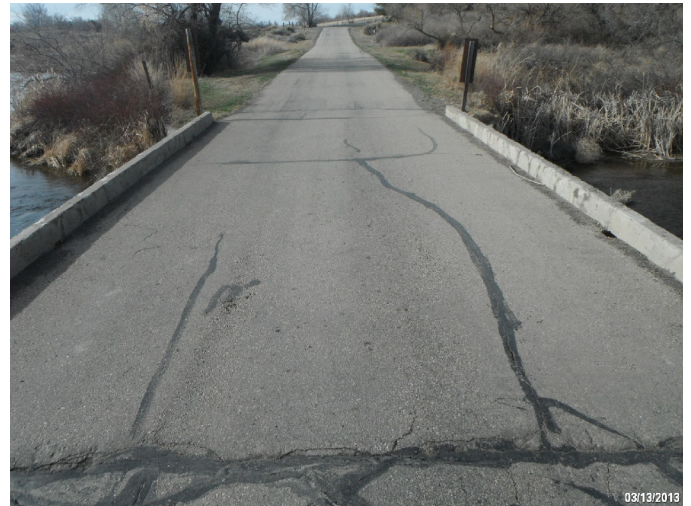
Hagerman NFH Bridge Inventory					
Rte #	Milepost	NBIS #	Sufficiency Rating	Functionally Obsolete	Structurally Deficient
010	0.08	14230-00031	709	N	Y

Photo: HANF_C4_0227 Route: 010-001-0.08
Asphalt Bridge NBIS:14230-0031

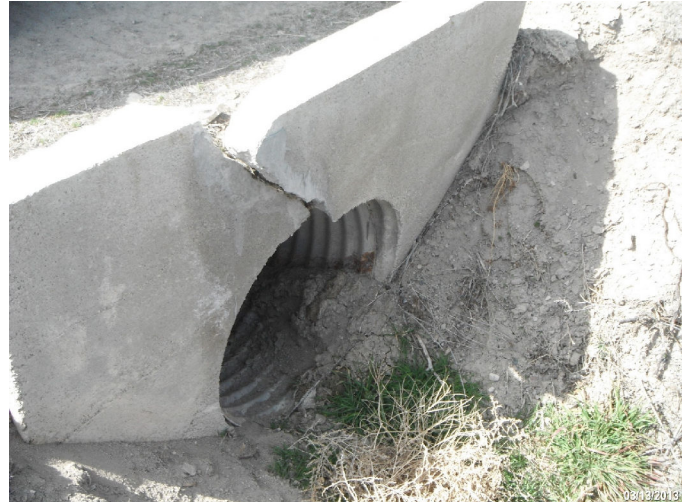
Photo: HANF_C4_0186 Route: 400-001-0.33
Metal Culvert 14ft long 24in dia. 2ft deep

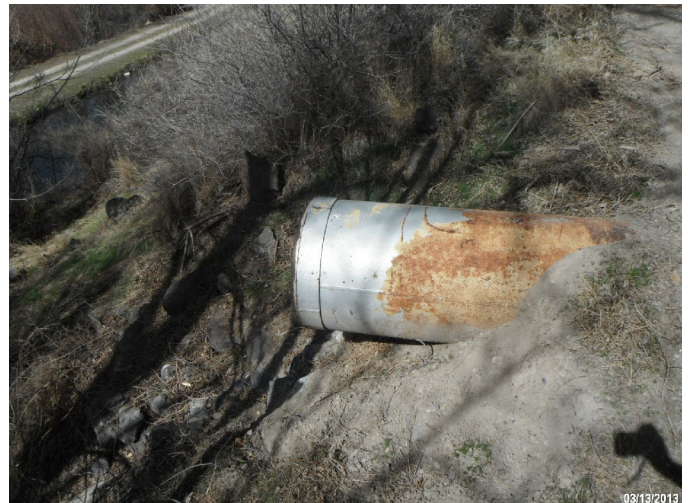
Photo: HANF_C4_0188 Route: 400-001-0.39
Metal Culvert 20ft long 24in dia. 1ft deep

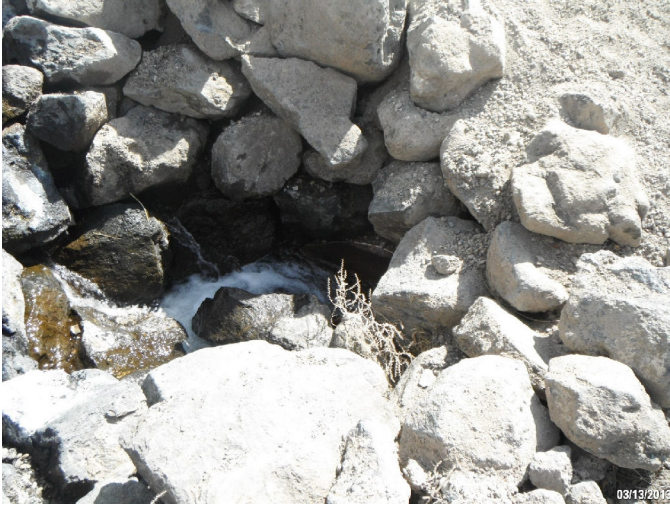
Photo: HANF_C4_0189 Route: 400-001-0.42
Metal Culvert 30ft long 24in dia. 2ft deep

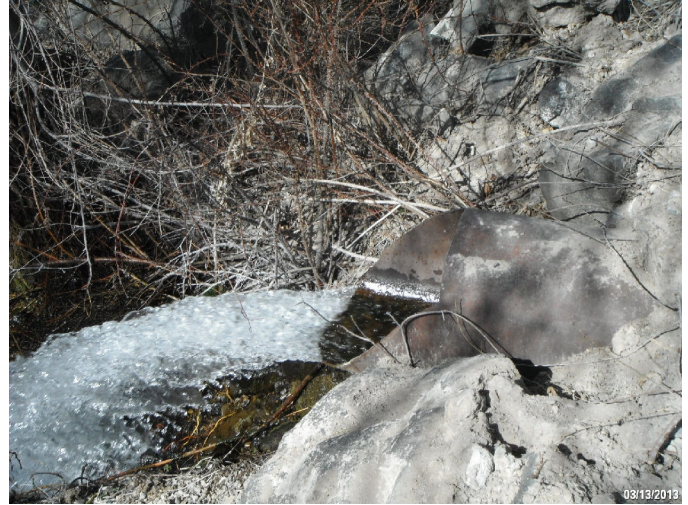
Photo: HANF_C4_0190 Route: 400-001-0.42
Metal Culvert 30ft long 24in dia. 2ft deep

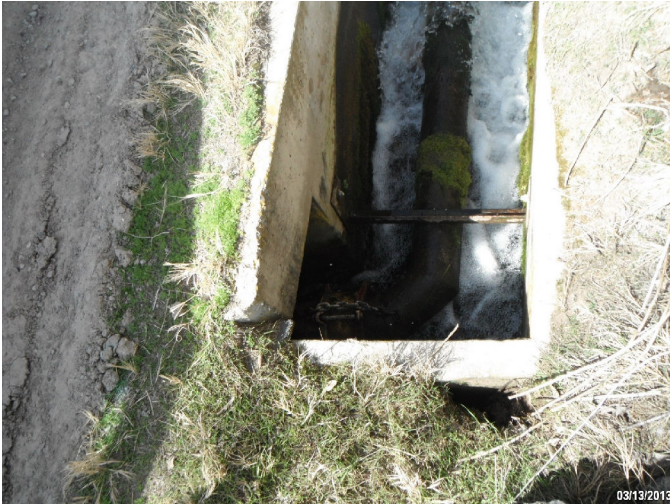
Photo: HANF_C4_0191 Route: 400-001-0.49
Concrete Culvert Box 16ft long 3ft x 2ft 1ft deep

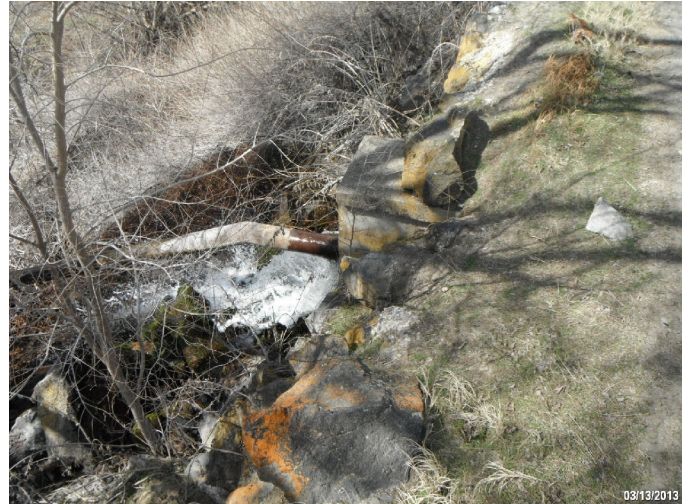
Photo: HANF_C4_0192 Route: 400-001-0.49
Concrete Culvert Box 16ft long 3ft x 2ft 1ft deep
